Interim Report Soil Removal and Confirmation Sampling

Former Citrus Processing Plant
616 E. Sunkist Street
Ontario, California

July 31, 2009

Project Number 08010002

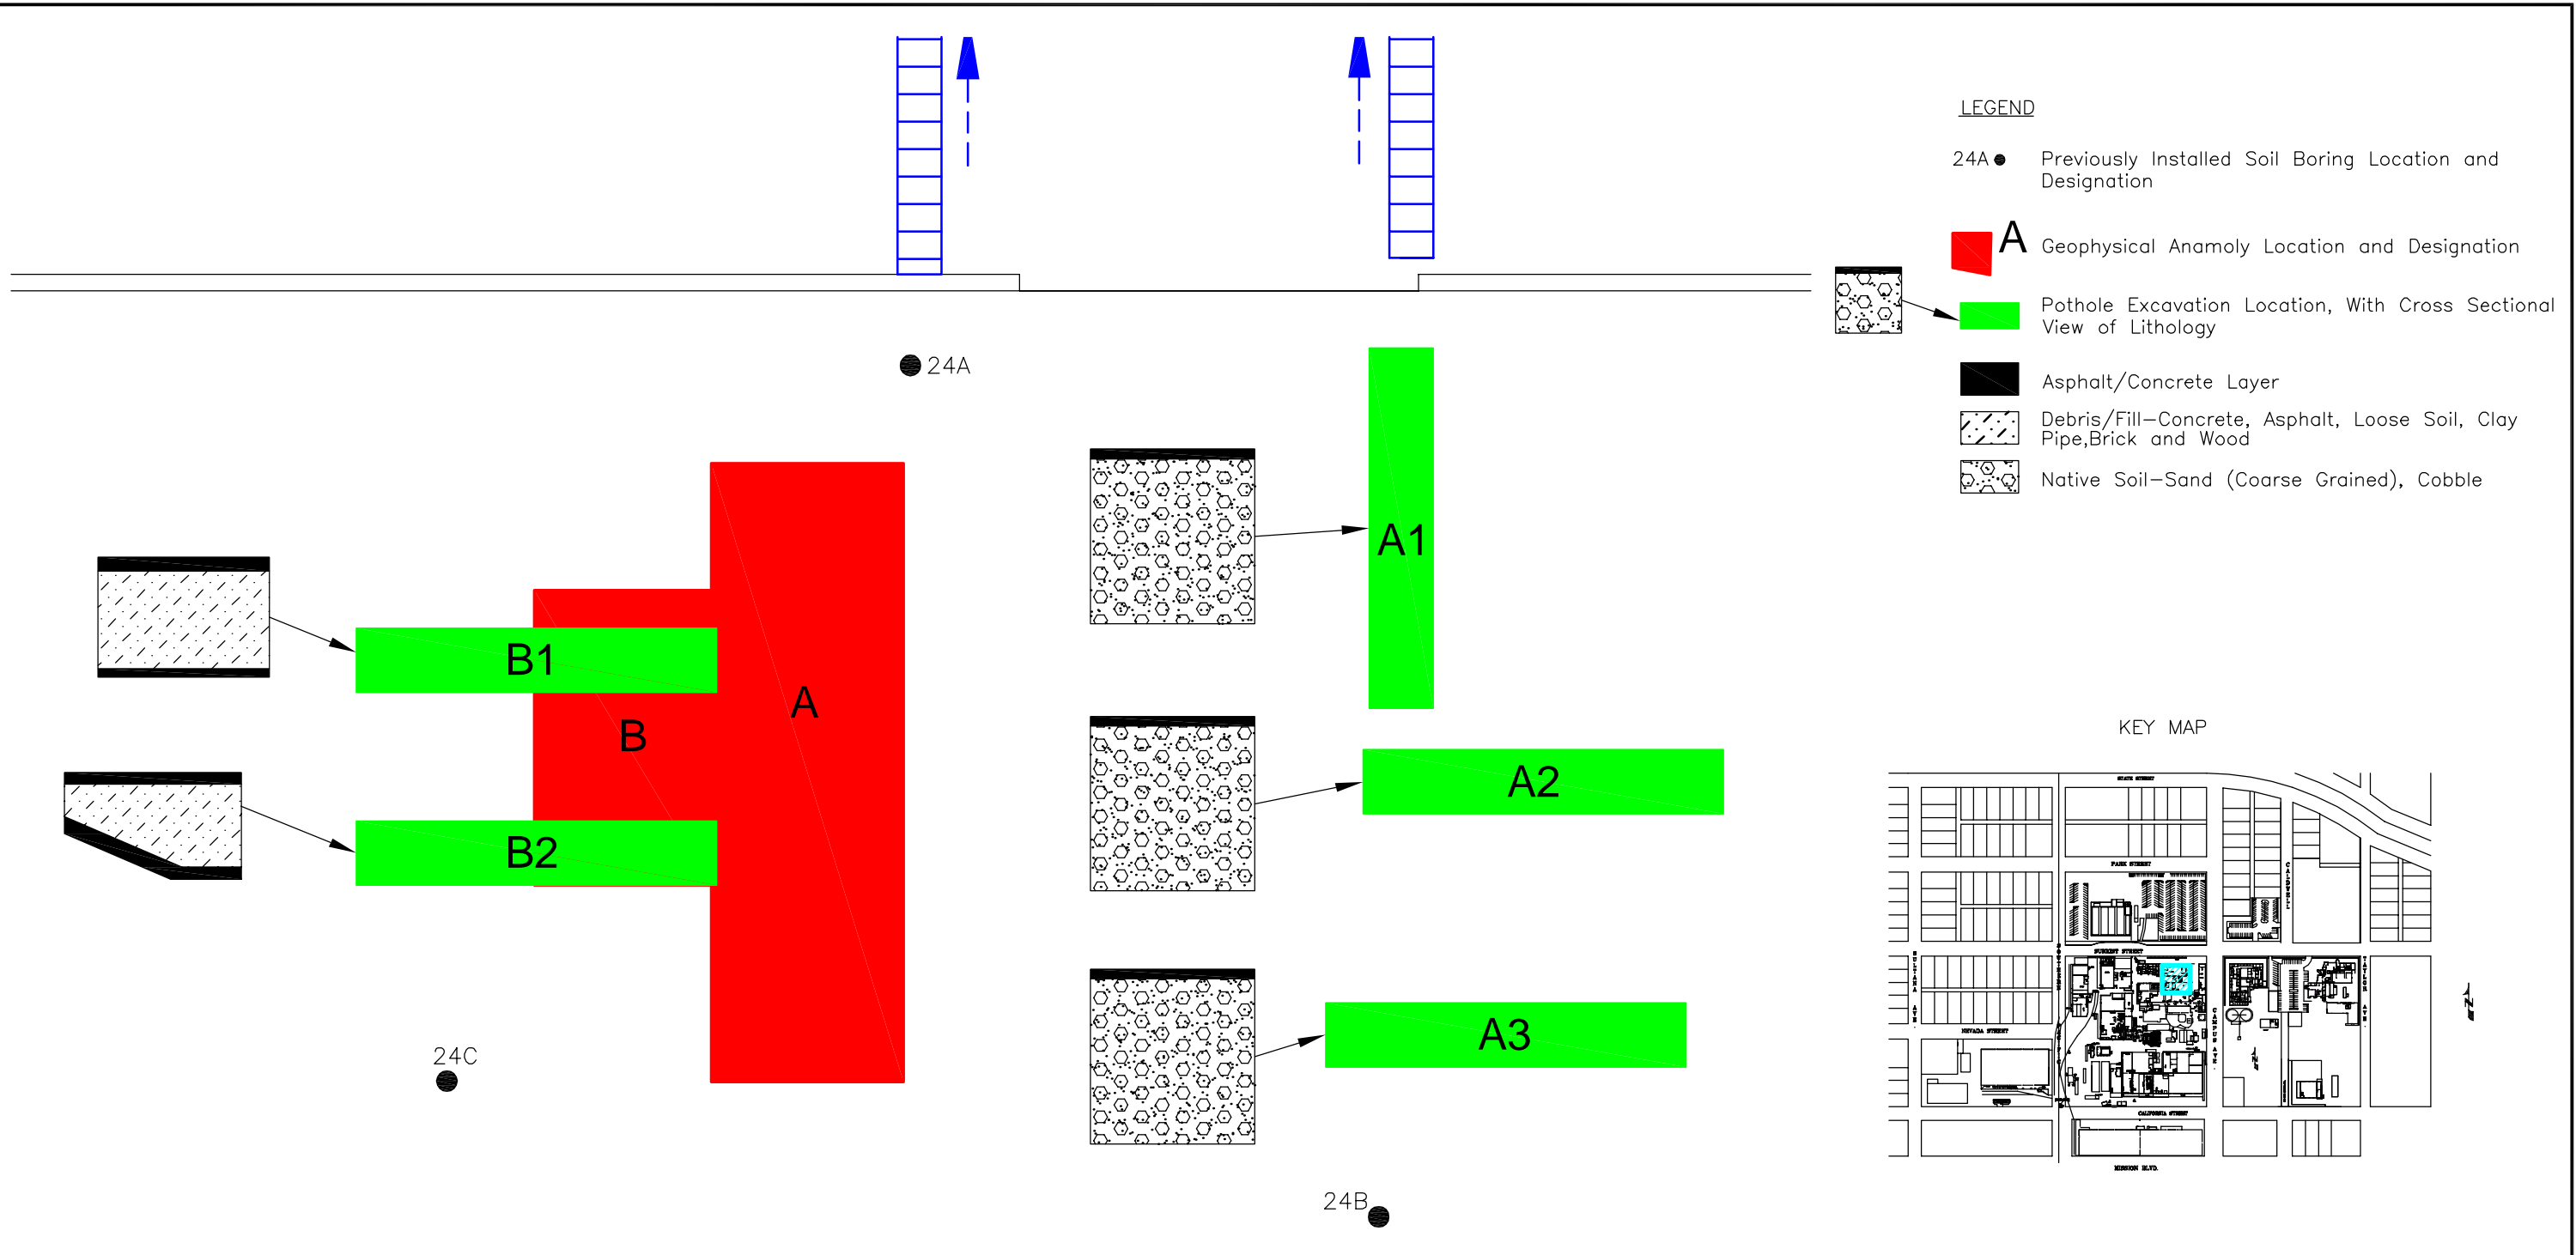
Figure 9

Note:
Cross sectional views are scaled at approximately 50%
of plan view scale.

BEC 16458 Bolsa Chica Street, #422 Huntington Beach, CA 92649 Tel. (877) 232-4620 Fax (714) 840-4963	POTHOLES IN AREA A AND B SUNKIST CITRUS PROCESSING PLANT 616 East Sunkist Street, Ontario, California	Project No. 08010001	Figure 8
--	---	---	--------------------------------	--------------------

Five pothole excavations were advanced in Areas A and B to depths of 5.5 to 10 feet, as shown on Figure 8. The two western potholes (B1 and B2) were installed over Area B. The presence of significant debris, in the form of concrete, asphalt, loose soil, clay pipe, brick and wood, was found to be

present to depths of 5.5 to 6 feet in these pothole excavations. At the lower depth a solid, bowl-shaped concrete foundation was found to be present in both B1 and B2. No debris (only native soil) was observed in the three eastern pothole (A1, A2, and A3), which were actually installed just to the east of Area A.

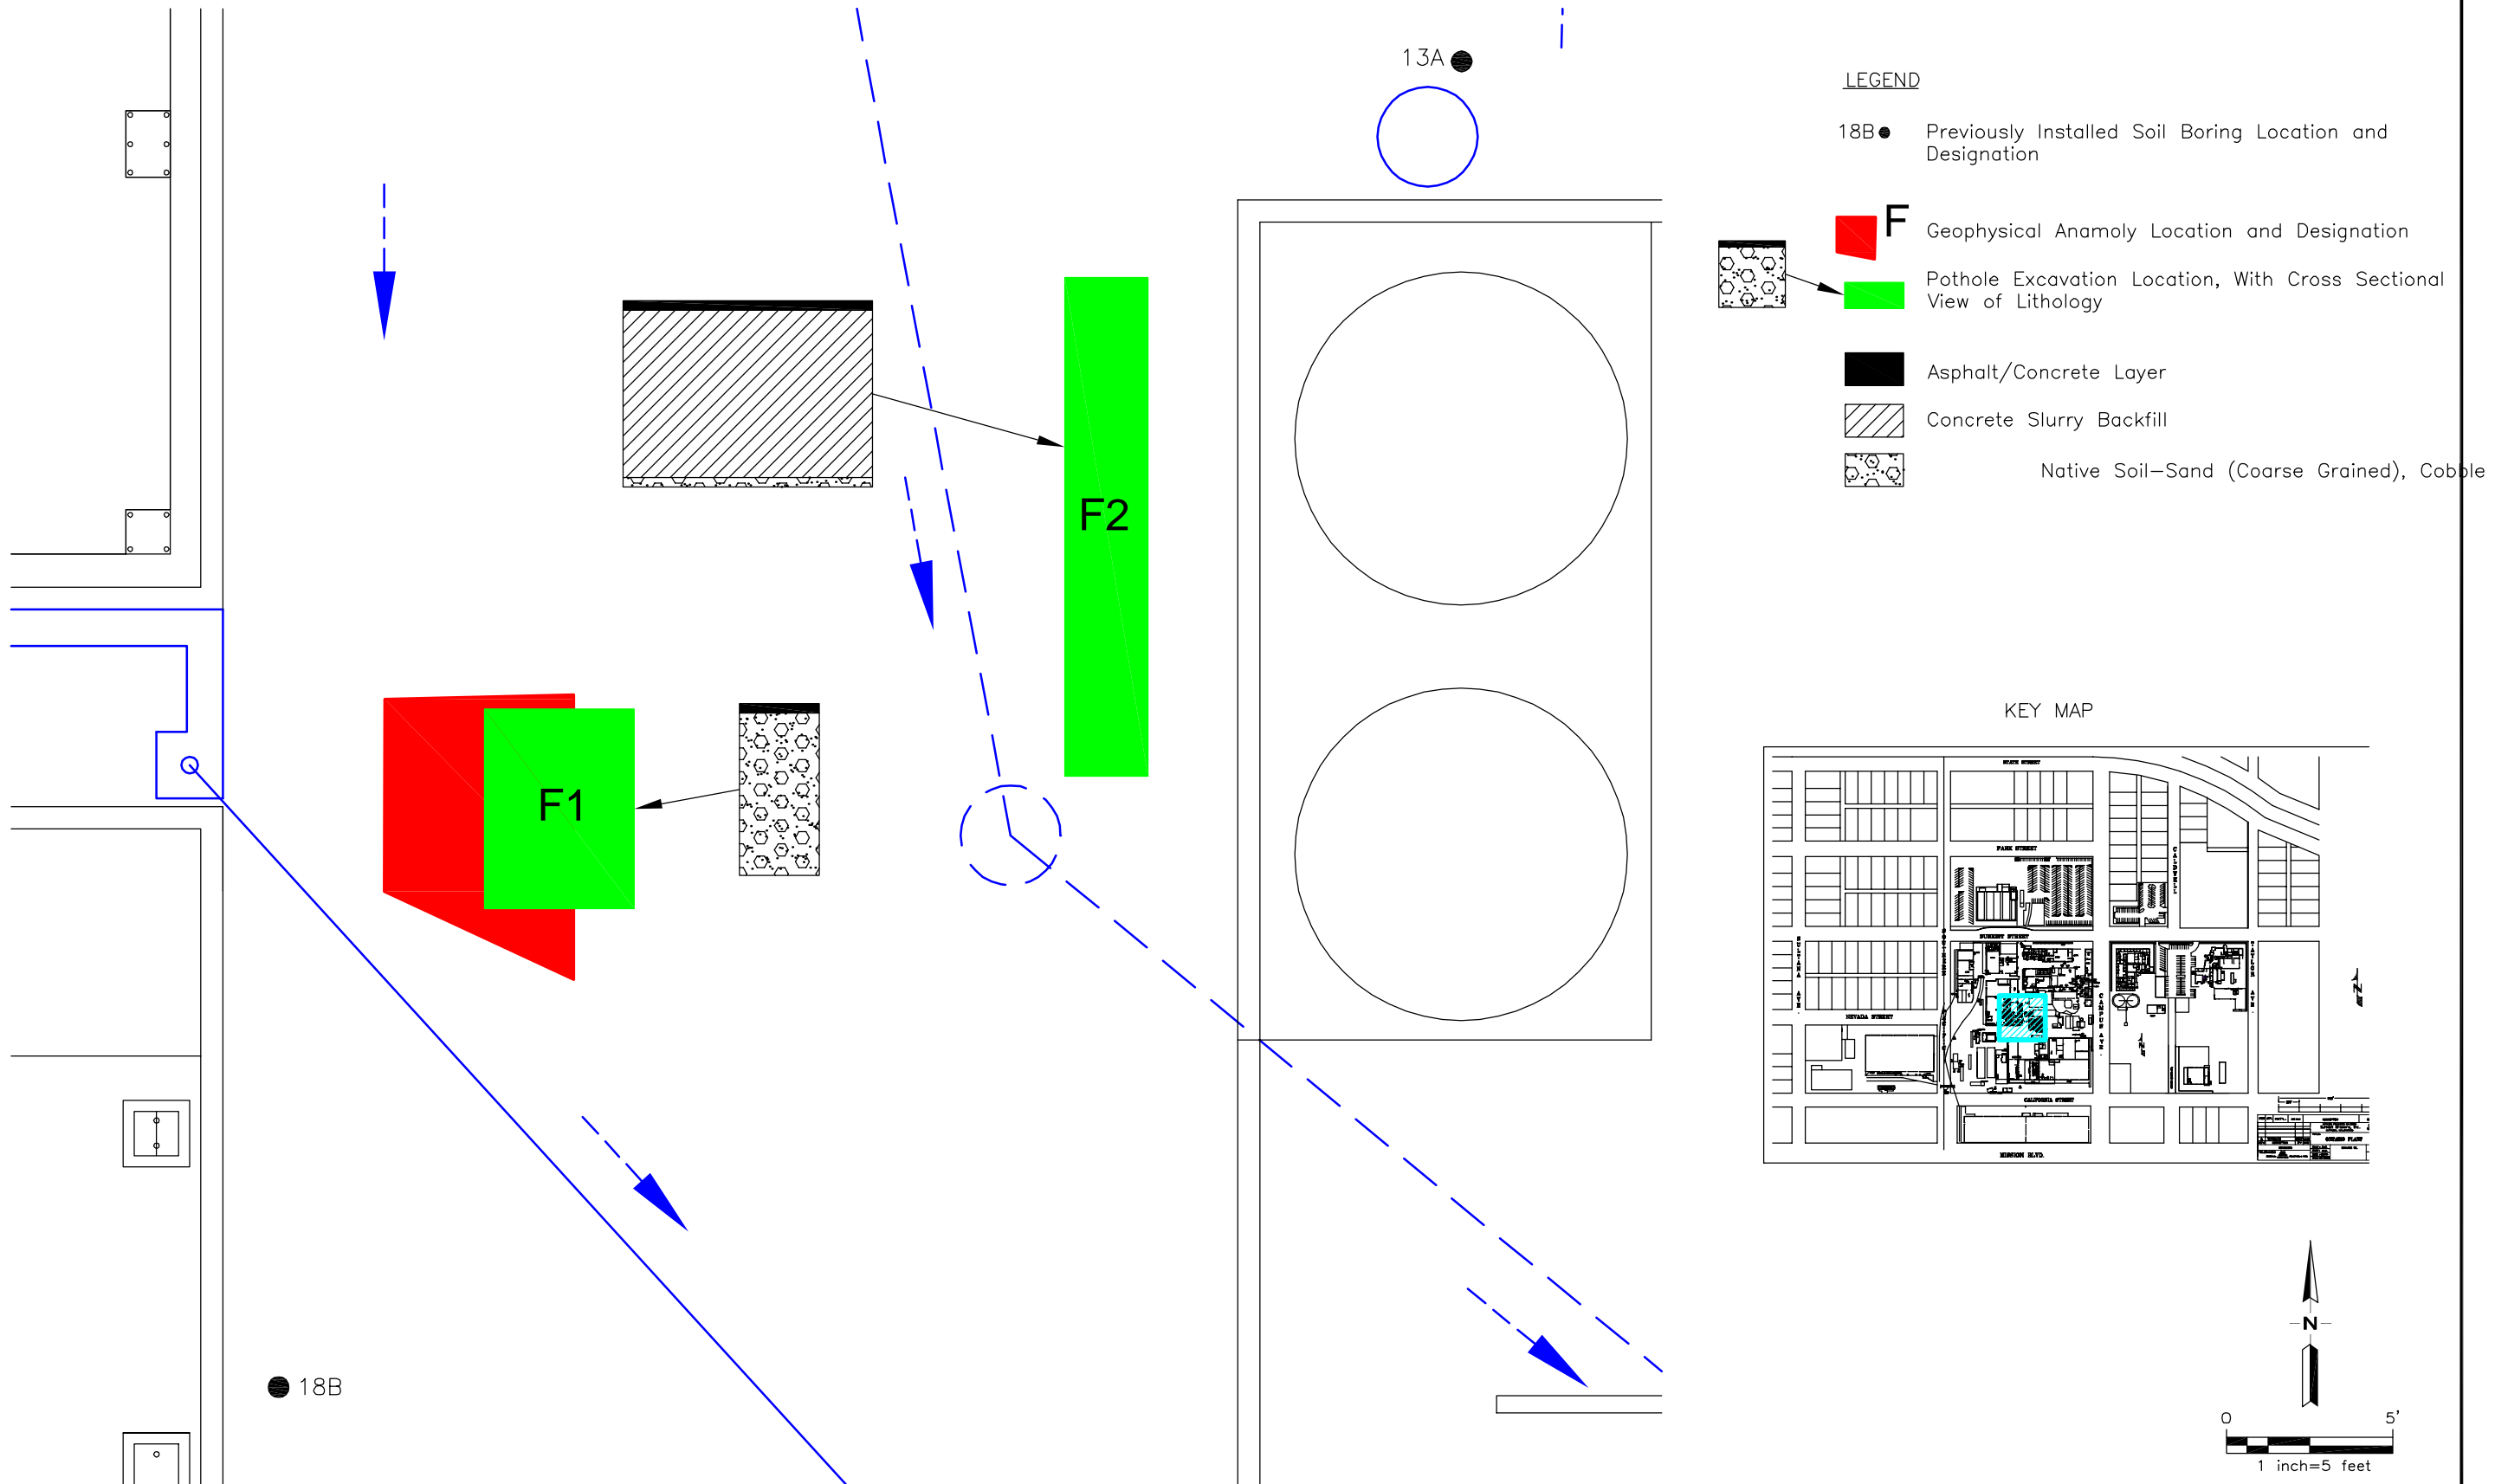
Project No. 08010001	Figure 11
-------------------------	--------------

POTHOLES IN AREA F
SUNKIST CITRUS PROCESSING PLANT
616 East Sunkist Street, Ontario, California

Two pothole excavations were advanced in Area F to depths of 10 to 11 feet, as shown on Figure 11. A 10,000 gallon diesel fuel UST was reported to have been formerly present in this general area. This diesel UST was reportedly removed on March 19, 1992. The slurry backfill encountered at up to 11 feet in Pothole F2 is most likely associated with this former UST. This area is also underlain by numerous underground lines, and the original anomaly may have also been associated with these known features. Other than the slurry backfill, only native soil was observed in the pothole excavations advanced in this area.

Anomaly F - No existing USTs or other suspect subsurface features were identified in relation to this anomaly. It is likely that the geophysical response observed in this area are a result of pipelines and/or the slurry

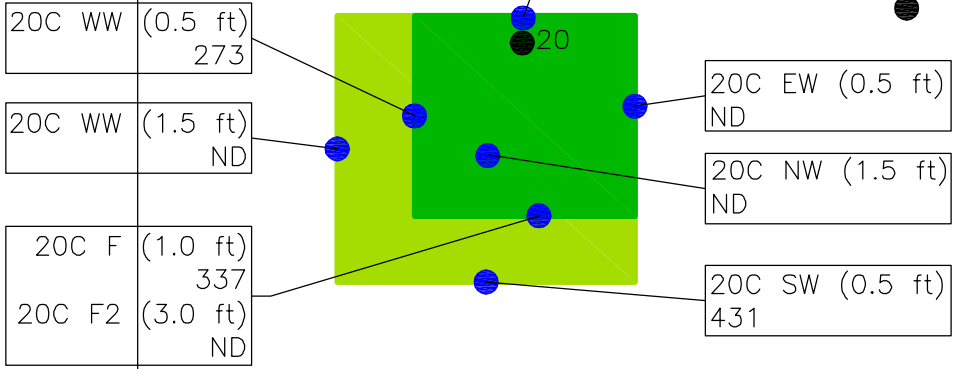
Figure 14

- Boring Location
- 20C NW (0.5 ft) ● Soil Sampling Locations
ND (Excavated—See Table 4 for Results and
Sampling Depths)
- Soil Excavation No. 1 to 1.0 ft (April 24, 2009)
- Soil Excavation No. 2 to 3.0 ft (May 7, 2009)

EXCAVATION AREAS AND PCB RESULTS IN AREA 20

As shown, the only detected PCB in Area 20 is Aroclor 1260. It was observed in 3 of the 8 samples collected from this area. The highest concentration observed was 431 mg/kg which is not higher than the TSCA waste criteria, but is higher than the conservative screening criteria which are being used as the default cleanup criteria for this work.
